**Effects of Docks on Submerged Aquatic Vegetation in
Lakes Butler and Jessamine,
Orange County, Florida**

October 2007
Final Report

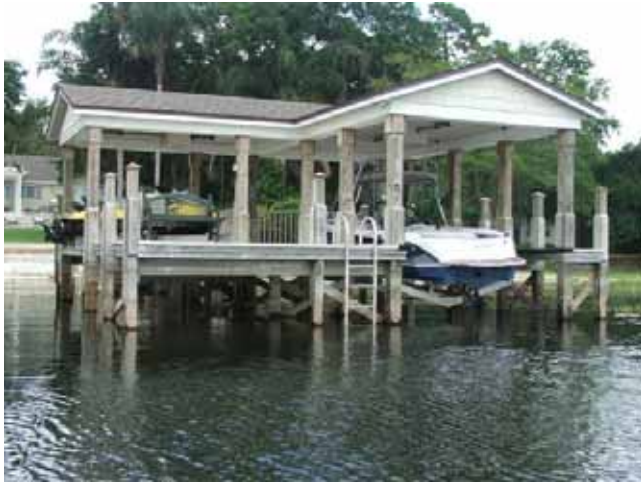
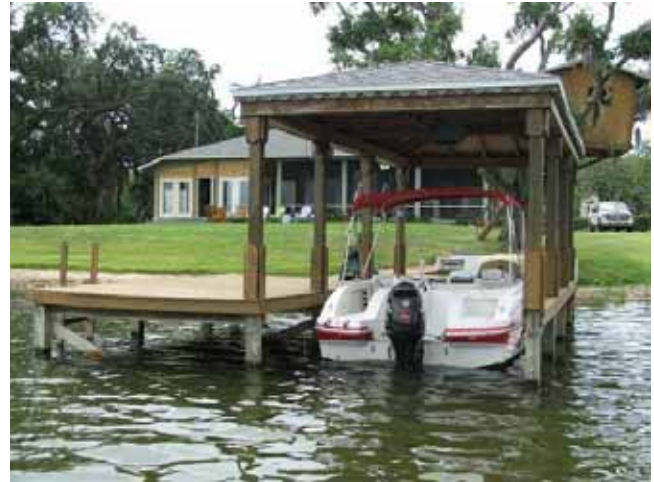
Figure 1. Examples of the docks that were surveyed in Lake Butler (A) and Lake Jessamine (B).

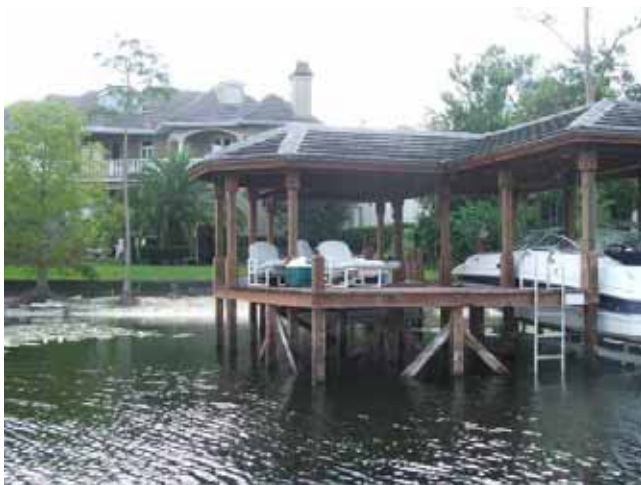
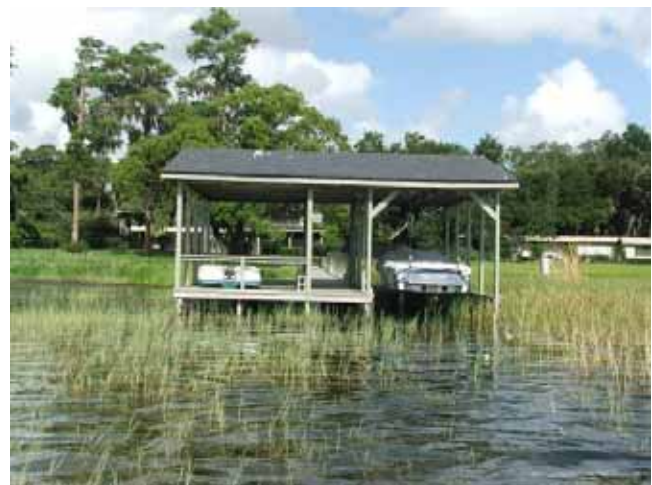
Figure 3. Docks surveyed in Lake Butler (A) were significantly higher ($p < 0.05$) above the water than docks surveyed in Lake Jessamine (B).

of the terminal platform above water for docks surveyed in Lake Butler was significantly higher than docks surveyed in Lake Jessamine ($F = 103.565$, $p < 0.0001$) (Figure 3 and Table 3). The water depth at the waterward end of the terminal platforms of the docks surveyed in Lakes Butler and Jessamine was not significantly different ($F = 2.356$, $p = 0.1422$) (Table 3). The average water depth at the waterward end of reference sites in Lakes Butler and Jessamine was not significantly different (1.08 m, 0.91 m, $F = 2.217$, $p = 0.1538$); water depths at the waterward end of surveyed reference sites ranged from 0.60 to 1.72 m in Lake Butler and 0.56 to 1.20 m in Lake Jessamine (Table 6). The substrate under all docks surveyed in Lake Butler was sand, while half of the docks surveyed in Lake Jessamine had muck underneath (Table 2). For reference sites in Lake Butler, the substrate type was sand with the exception of one site, and half of the reference sites in Lake Jessamine had muck substrate (Table 6).

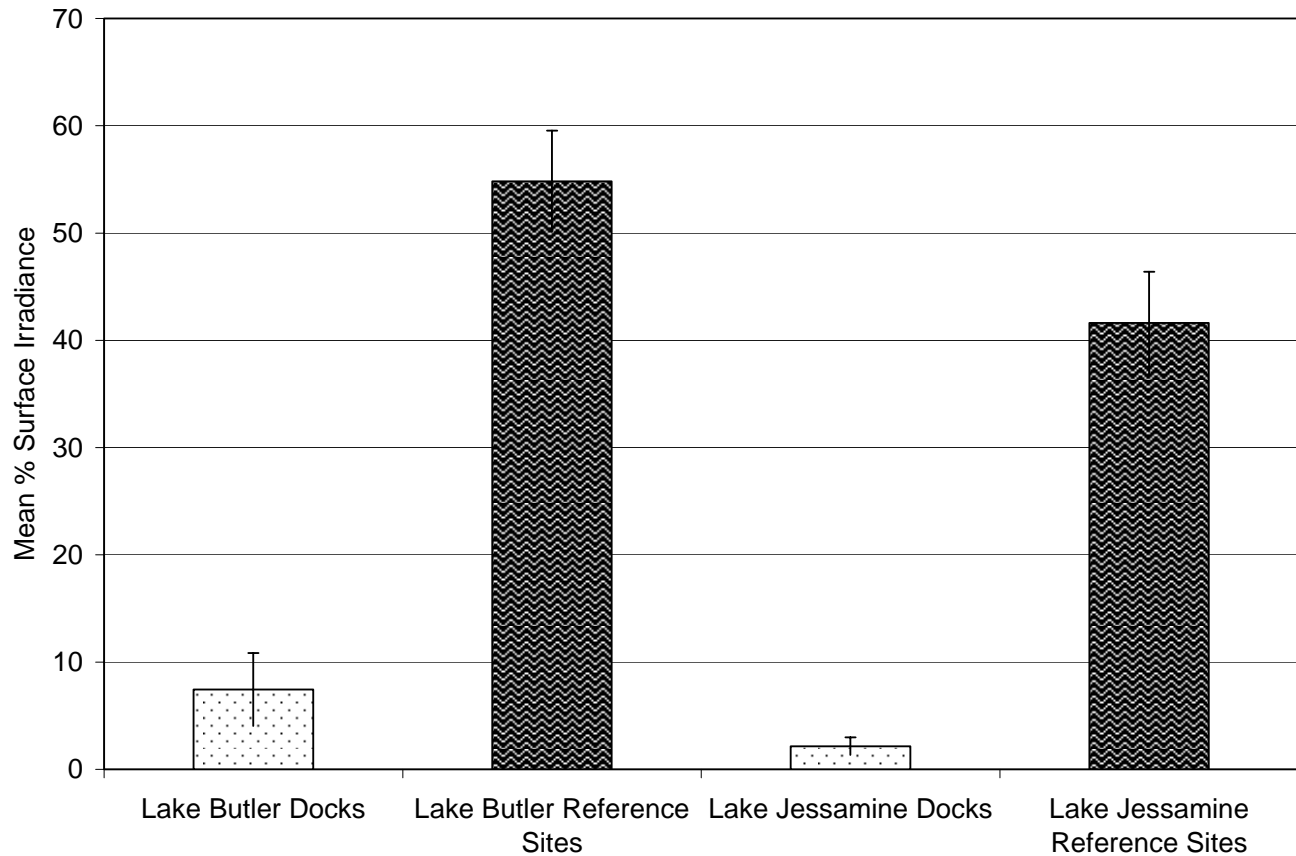
Figure 4. The mean percent surface irradiance just above the SAV/bottom for Lake Butler docks (n = 10), Lake Butler reference sites (n = 10), Lake Jessamine docks (n = 10), and Lake Jessamine reference sites (n = 10), Orange County, Florida, 25 June Through 6 July 2007. Error bars represent the standard error.

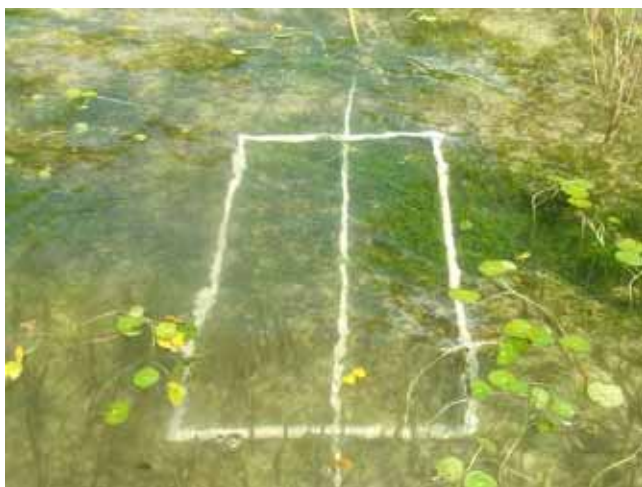
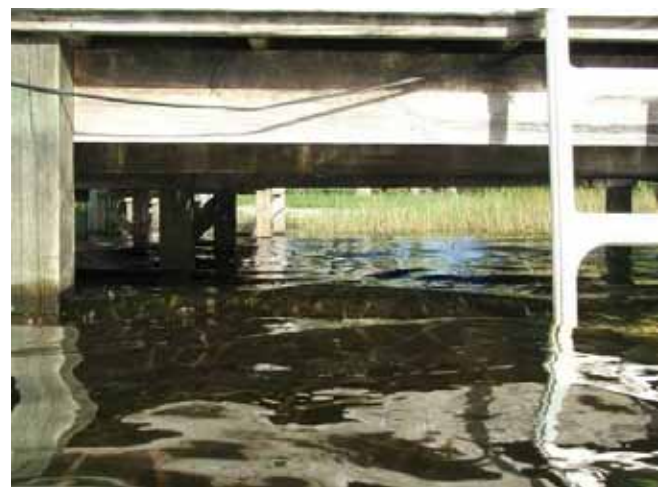
Figure 5. Differences in the size of SAV in Lake Butler (A) and Lake Jessamine (B).

Six species of SAV were found in both lakes: coontail (*Ceratophyllum demersum*), eelgrass (*Vallisneria americana*), hydrilla, Illinois pondweed (*Potamogeton illinoensis*), leafy bladderwort (*Utricularia foliosa*), and stonewort (*Nitella* spp.) (Tables 14 and 15 in Appendix B). Lemon bacopa (*Bacopa caroliniana*), muskgrass (*Chara* spp.), and southern naiad (*Najas guadalupensis*) were found only in Lake Butler, while spikerush (*Eleocharis* spp.) was observed only in Lake Jessamine. The SAV in Lake Butler was thin and small compared to the SAV that occurred in Lake Jessamine, which was often very large, very dense, and grew to the lake surface (Figure 4).

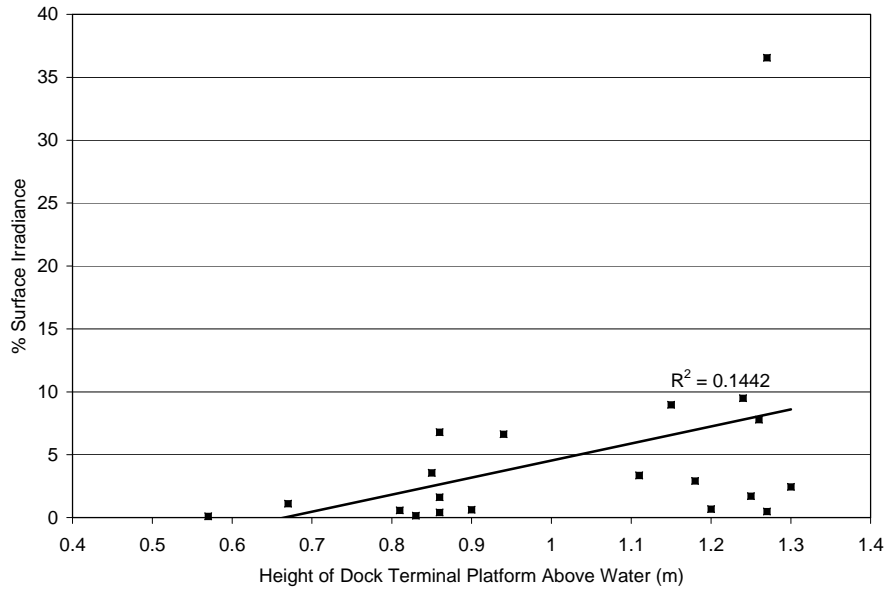
Figure 10. The Relationship the Height of the Dock Terminal Platform Above Water and the Percent Surface Irradiance Just Above the SAV/Bottom for Surveyed Docks in Lakes Butler and Jessamine, Orange County, Florida, 25 June Through 6 July 2007.

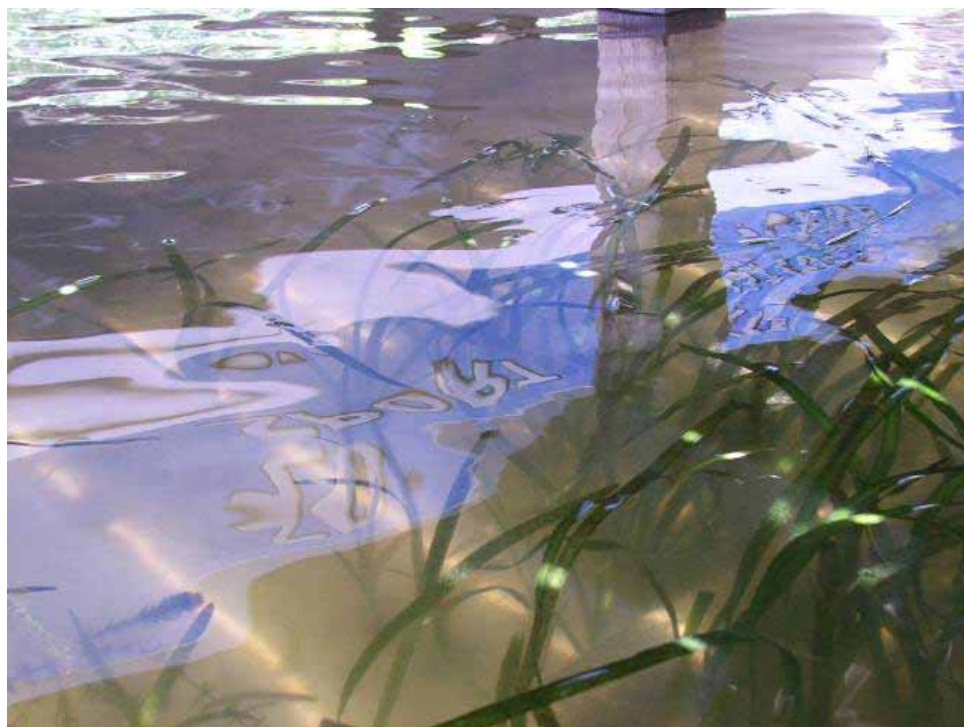
Figure 12. Light Penetrating Beneath a Dock Through the Plank Spaces in Lake Jessamine.

populations in two estuaries in Massachusetts were impacted under and directly adjacent to docks, as shown by depressed shoot density and canopy structure; they identified dock height as the most important factor affecting light intensities and plant densities, and dock orientation and width were also important factors. Since the widths of the docks surveyed in both lakes were similar, the effect of dock width on light penetration or plant density could not be evaluated in this investigation. Similar to what was found by Burdick and Short (1999), SAV density was significantly higher under docks oriented north/south compared to those oriented east/west in Lakes Butler and Jessamine. In a study conducted in Perdido Bay, Alabama, Shafer (1999) attributed the continued survival of seagrasses under docks to their north/south orientation. While dock plank spacing was determined not to be a significant factor in this study, observations during mid-day surveys indicated that surface light penetrated beneath the dock through the spaces in the planks (Figure 12).

4. Plank Spacing: Plank spacing was not a significant variable in this study, but observations during surveys indicated that light penetrated beneath docks through the spacing in the planks. Therefore, spacing in the planks is recommended over planks with no spacing. Shafer and Lundin (1999) recommend the gaps between boards be a minimum of 12.7 mm (0.5 inches) in order to minimize impacts to seagrasses. The results of a study conducted on eelgrass under docks in the Lower St. Johns River indicated that innovative alternatives that increase light beneath docks should be investigated to provide homeowners with additional options for dock construction (Steinmetz et al. 2003, 2004). Terminal platforms constructed of fiberglass grids have been shown to reduce the amount of seagrass loss due to shading by docks and terminal platforms (Shafer and Robinson 2001).

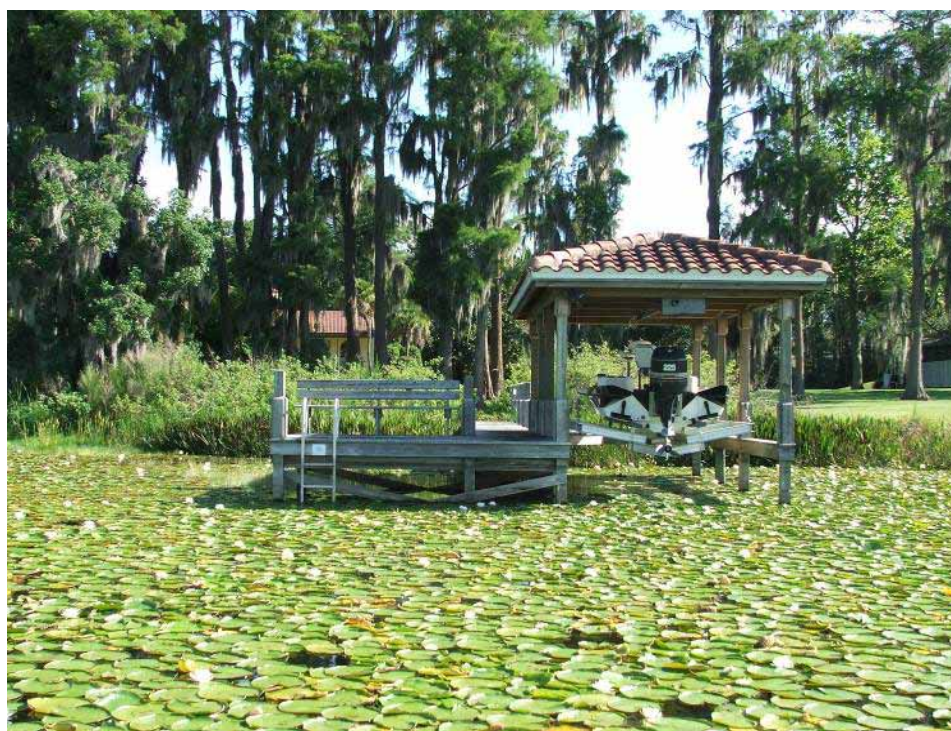
Figure 13. Example of a Dock in Lake Jessamine That is Completely Surrounded by High Densities of Submerged and Floating-Leaved Vegetation.
